SITE & BUILDING CONSTRUCTION EVALUATION

Section 1 Site Access

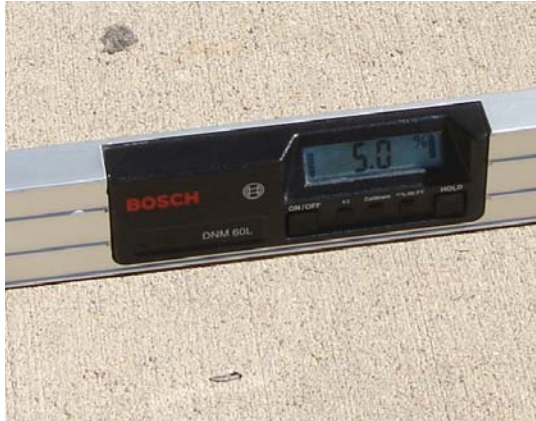
Cross slope at landing (#0919), above

From the curb ramp, there was no accessible route to the front entry provided. The landing where the sidewalk turns 90 degrees had a cross slope of 5.0% in one direction (2% maximum allowable), the sidewalk had cross slopes up to 4.4% (2.0% maximum allowable) and the curb ramp had a cross slope of 5.7% (2.0% maximum allowable) and the curb ramp lacked required detectable warnings (ANSI 4.7.2, 4.8.2 and 4.27).

All curb ramps on site must comply with the requirements of ANSI 4.7 Curb Ramps and 4.27 Detectable Warnings.

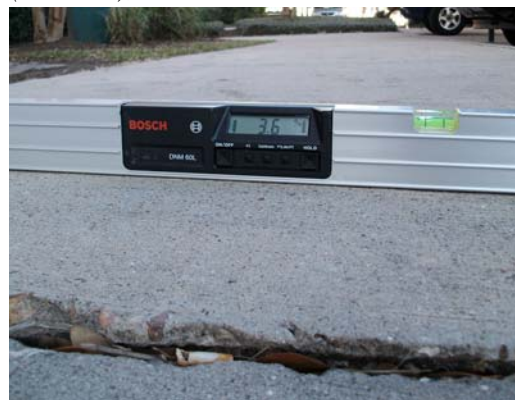
Cross slope at Building #3 Sidewalk (#S0390), below

This sidewalk connected to a sidewalk at Building #3 which was not accessible. The walk had cross slopes greater than 2% (3.6%) and it dead ended into the side of a parking space which could be blocked by a car.

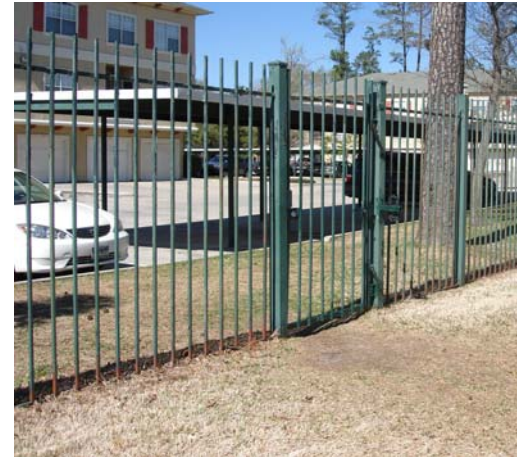
*School bus stop (#0990), left
Gate at school bus stop ((#0991),
below*

The school bus serving the complex stopped daily on Compaq Drive. Children were dropped at a grassy area and passed through a side gate to a carport/parking area and to a vehicular lane. No accessible route was provided in any portion of this pathway.

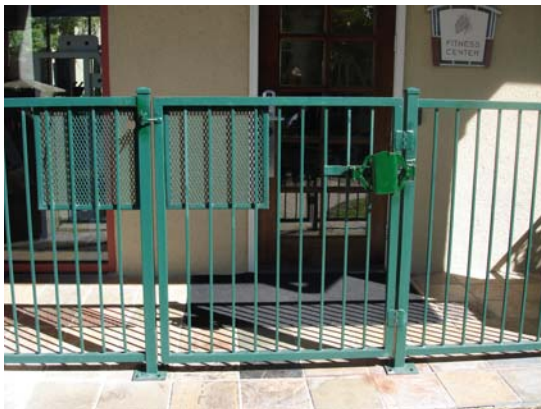
Gate at the Fitness Center (#0885)

The gate at the fitness center had a push up latch which required that the user push up and pull forward simultaneously. To operate the latch from the fitness room side, the user had to reach over the gate to pull up the latch on the pool side and then push the gate forward. The top of the gate was at 51 inches above the concrete and 12 inch required approach area on the pull side was not provided (8 inches) (ANSI 4.13.6). The force required to operate the gate was 9 pounds which is more than the 8.5 pounds permitted in exterior locations (ANSI 4.13.11).

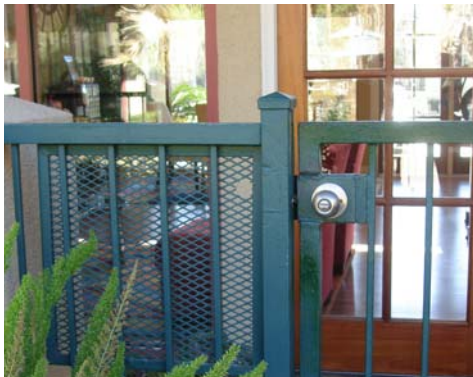
Gate at leasing office (#0898)

The gate at the leasing office building had a knob latch set which required pinching and twisting to operate (not allowable per ANSI 4.13.9), required more than 8.5 pounds of force to operate (9 pounds) and did not have a level landing with slopes no more than 2% on the leasing office side of the gate (2.4%). (ANSI 4.13.11 and 4.3.7).

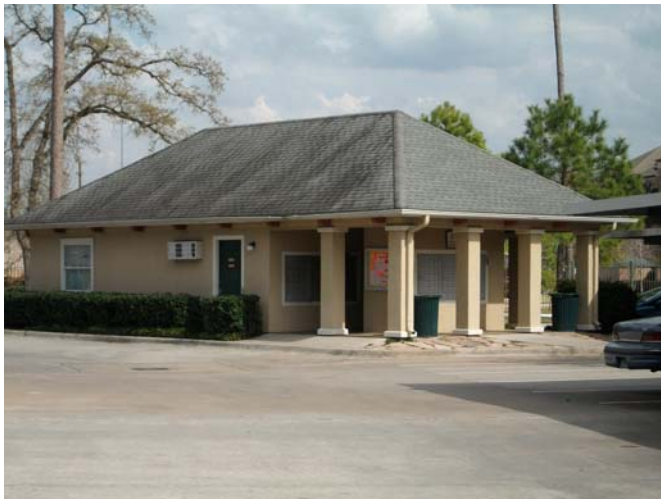
Mail Center from Bldg 4, (S#0322)

There were no accessible routes connecting to this island or serving this building. On the Building 3 side, there was one accessible parking space designated. The sidewalk between this parking space and the mail building was not accessible. The cross slopes at the landing at the end of the access aisle and the sidewalk connecting the mail building with the rest of the complex were greater than 2% (up to 5.1%) (ANSI 4.3.7). The running slope at the sidewalk to the landing had running slopes greater than 8.33% (10.8%) (ANSI 4.8.2).

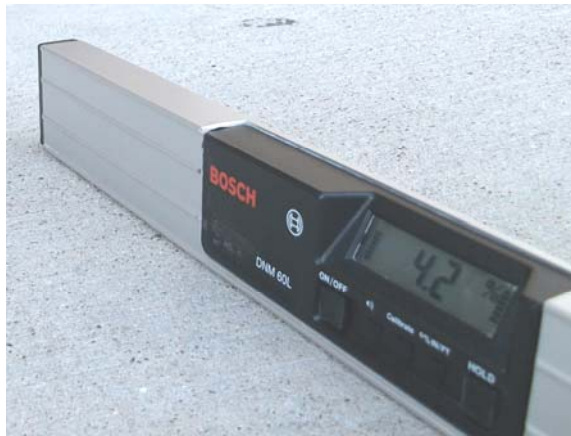
*Bldg 2, Right Breezeway (#S0426)
Level at sidewalk cross slope (#S0432)*

The right breezeway had a sidewalk that extended straight out to the drive lane and a curb. At one side, the sidewalk ended at the side of a parking space behind the garages. There was no detectable warning at the blended transition to the parking space nor was there a curb ramp or detectable warning at the curb at the vehicular lane. The cross slope on the sidewalk crossing in front of the stair and ending at the parking space was 4.2% which is greater than the 2% maximum allowed (ANSI 4.3.7).

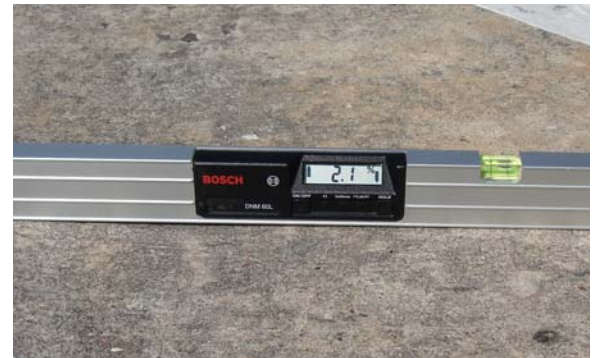
Level at Game Room Space (#0968)

A portion of the access aisle did not comply with the maximum 2% slope requirement (2.1%). “Parking spaces and access aisles shall be level with surface slopes not exceeding 1:50 (2%) in all directions.” (ADA Std. 4.6.3, ANSI 4.3.7). The curb ramp and sidewalk to the leasing office from this space was not accessible (see Page 1-1).

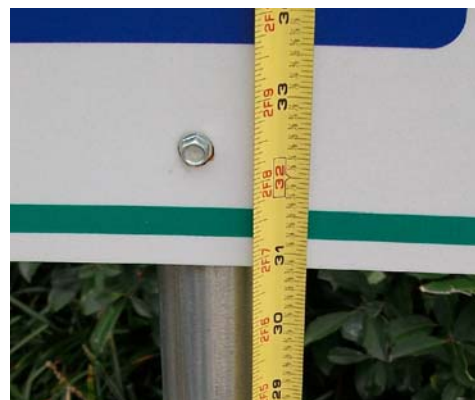
There was one accessible space by this building. The sign for the space was not mounted high enough to be visible above and beyond a vehicle parked in the space (ANSI 4.6.2). No accessible route was provided from the parking space to any building entry.

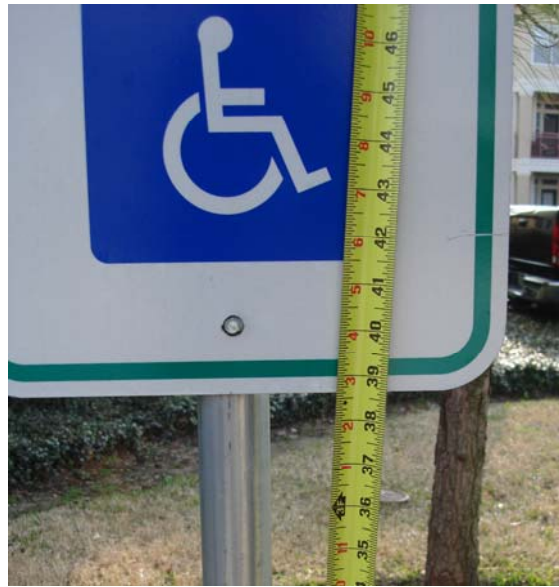
There was one accessible space by this building. The sign for the space was not mounted high enough to be visible over a vehicle parked in the space (ANSI 4.6.2). No accessible route was provided from the parking space to any building entry.
